Gear Noise Cause of a Different Stripe

QUESTION

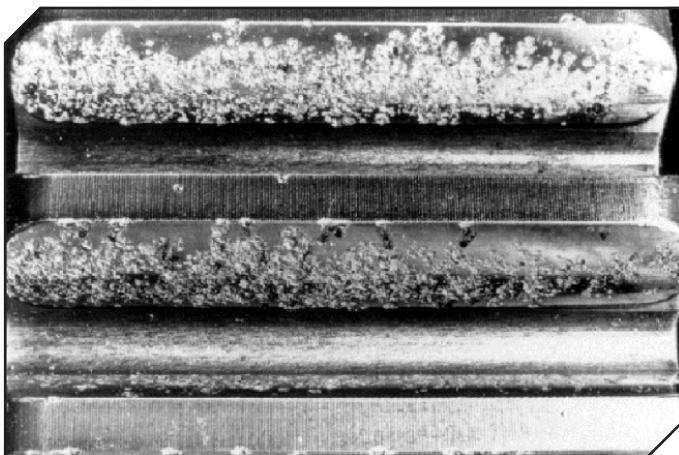
Figure 1 An example of tiger stripes failure (this image appeared as Fig. 2a in Ref. 1).

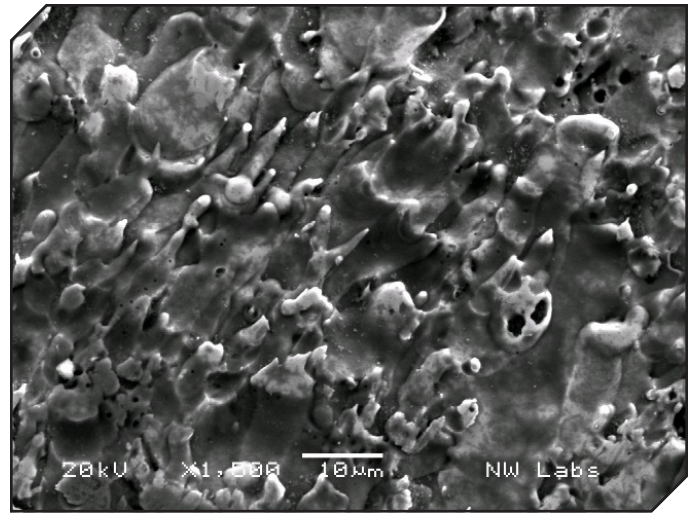
Figure 2 Electrical discharge damage can also appear as random distinct pits over the area of the surface (this image appeared as Figure 20 in Ref. 3).

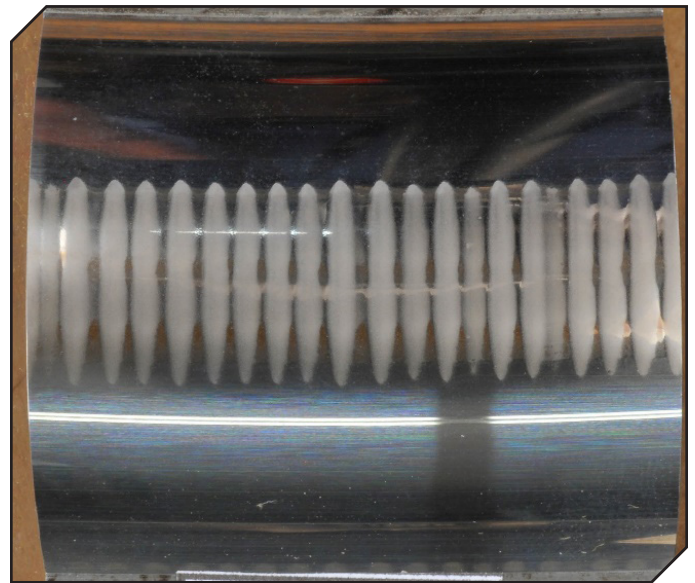
Figure 3 The morphology of the damaged surfaces generally consists of micropits with melted bottoms and globular material indicative of melting (this image appeared as Figure 2d in Ref. 1).
